# OMEGA: A NEW COLD X-RAY SIMULATION FACILITY FOR THE EVALUATION OF OPTICAL COATINGS

J. H. Fisher, C. D. Newlander, K. B. Fournier, D. E. Beutler, C. A. Coverdale, M. J. May, M. Tobin, J. F. Davis, D. Shiekh

May 1, 2007

Journal of Radiation Effects, Research and Engineering

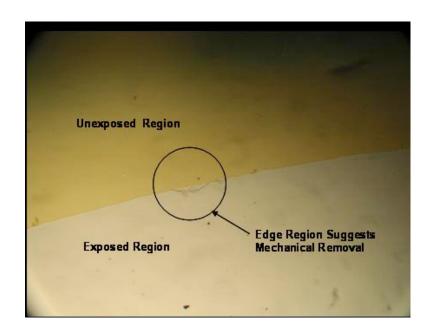
Figure 4. Photomicrograph of Specimen 1 (Shot 52).

Figure 4 shows one of the photomicrographs for Specimen 1 which was exposed on Shot 52 (which was tested without a filter). It exhibited the most damage – complete removal of the  $SiO_x$  coating over the exposed area. The edge region suggests that the material was removed by mechanical means rather than coating melt. Figures 5 and 6 present posttest photomicrographs of Specimen 8 (Shot 56) which showed  $SiO_x$  removal over several areas. Figure 6 is a close-up of one of those areas which shows that the silica coating has actually folded back upon itself – a strong indication of mechanical failure of hot material. Figure 7 presents a photomicrograph of Specimen 5 (Shot 54) which showed no visual damage.

Calculations were performed to determine the transverse stress wave response of the specimens. It was felt that the damage seen in the Shot 52, which was unfiltered, might be due to the stress waves generated in the silica coating due to the absorption of the low energy X-rays and UV. The stress wave transit time through the silica is very short (~0.01 nsec), and therefore the calculation was only run to 2 ns which would allow for many stress wave transit times through the silica layer to occur. Figure 13 shows the calculated peak stress envelopes for Shots 52 and 57 run to 2 nsec. The silica coating was completely removed in Shot 52 and intact in Shot 57. There is some very early time noise in Shot 52, but the trend indicates that the generated peak tensile stresses at the silica/gold interface could be nearly a factor of two larger in Shot 52 than in Shot 57. Tensile stress levels of about 0.2 kbars may be sufficient to fail the interface. Spall or delamination of the silica layer is probably the cause of the silica coating layer removal.

Shot	Specimen	Visual Observations	
52	1	Outer layer(s) completely removed over entire exposure area. Based on reflectance data, the silica layer has been removed. Analyses and exposure area edge description suggest mechanical removal, not melt or vaporization. Gold layer appears to be intact	
53	6	One very small area shows removal of silica (folded back on itself indicating mechanical interface failure. Remaining silica and gold coatings remain intact and undamaged	
54	5	No damage to either coating is evident.	
56	8	Silica coating removal at several areas. These areas appear to be a small percentage of the total exposed area. Close-ups of damaged area shows solid silica coating debris and folding of the layer at numerous locations.	
57	4	Beryllium filter fractured and failed on this shot. Specimens shows debris on the surface.	
58	7	No damage to either coating is evident.

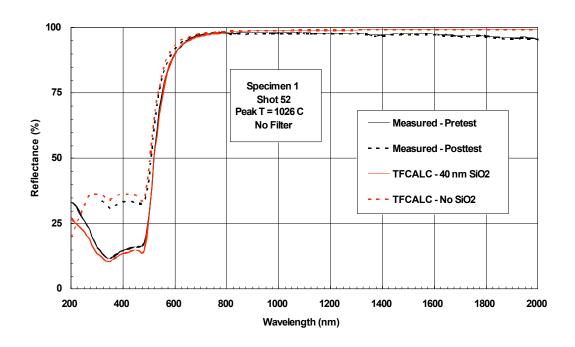
Figure 9. Pre- and Posttest Reflectance for Specimen 1 (Shot 52) and TFCALC Analysis
With and Without the Silica Coating

Figure 9 shows the reflectance measurements and TFCALC analyses for Specimen 1 (Shot 52) which was the unfiltered shot which showed complete removal of the silica protective coating. The posttest measurement shows an increase in the reflectance below about 800 nm. A TFCALC analysis was performed without the 40 nm silica protective coating which shows good correlation with the posttest measurement. This confirms that the silica coating was completely removed and that the removal did not affect the reflectivity of the gold layer.

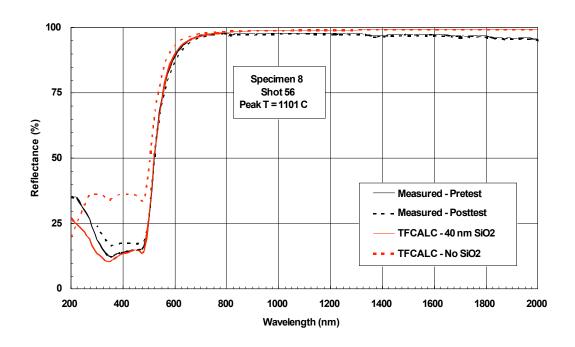
Figure 10. Pre- and Posttest Reflectance for Specimen 8 (Shot 56) and TFCALC Analyses

Figure 10 shows the reflectance measurements and TFCALC analyses for Specimen 8 (Shot 56). This specimen showed partial removal of the silica protective layer. The posttest measurement shows an increase in the reflectance below about 500 nm. It would appear that perhaps about 15% of the silica coating was removed. Again, there appears to be no degradation in the reflectance of the gold layer.
